## **Thorough cleaning makes concrete walls at IKEA as good as new**

The largest IKEA in Denmark is located in Odense. The department store has two floors, and if you walk through all the sections, the trip is no less than 2.5 kilometers long.

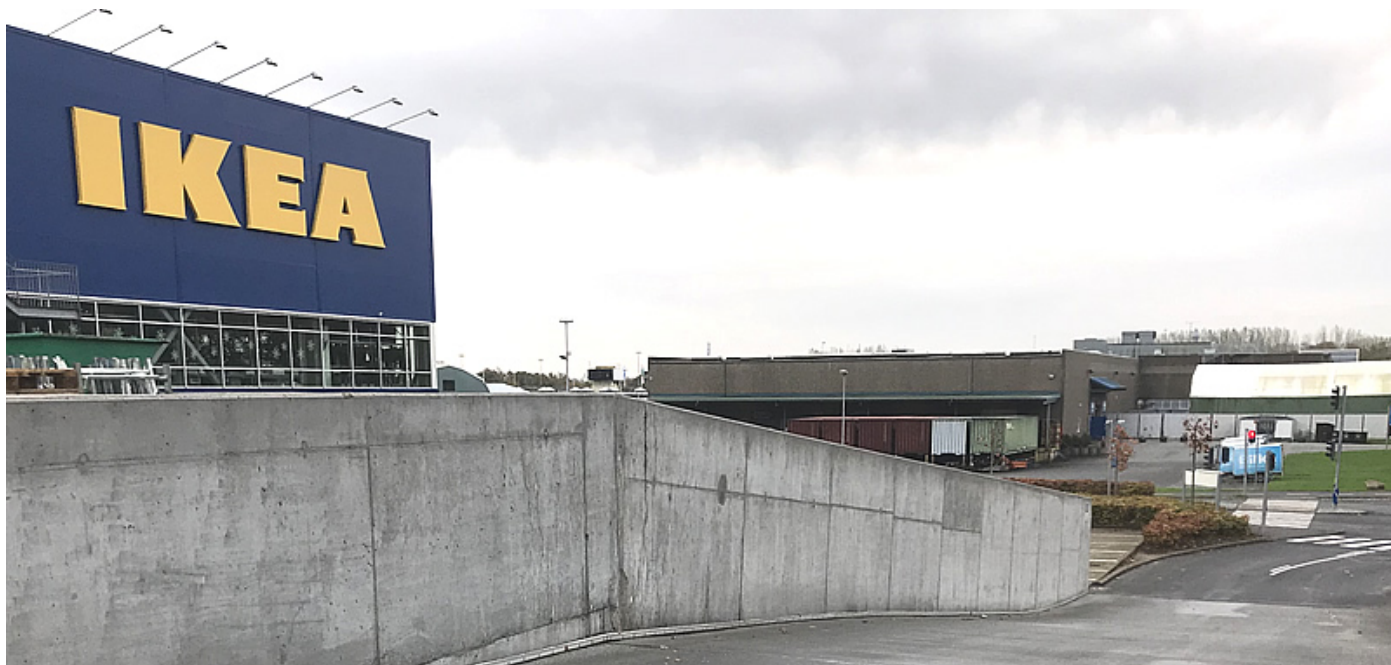
But because the walls were not impregnated back in 2009 when the store was built, the algae flourished on the walls and large curtains of filth were running down the sides.

First, the concrete was cleaned using hot water high-pressure cleaners. After the cleaning, all algae and dirt had been removed making the concrete surfaces light and uniform again.

Next, all the surfaces were impregnated with Faceal Oleo HD. This protection will make the

walls look presentable and clean for many years to come.
